**R44 SERVICE LETTER SL-92A**  
(supersedes R44 SL-92)

**R66 SERVICE LETTER SL-51A**  
(supersedes R66 SL-51)

**SUBJECT:** Main Rotor Flight Controls Inspections

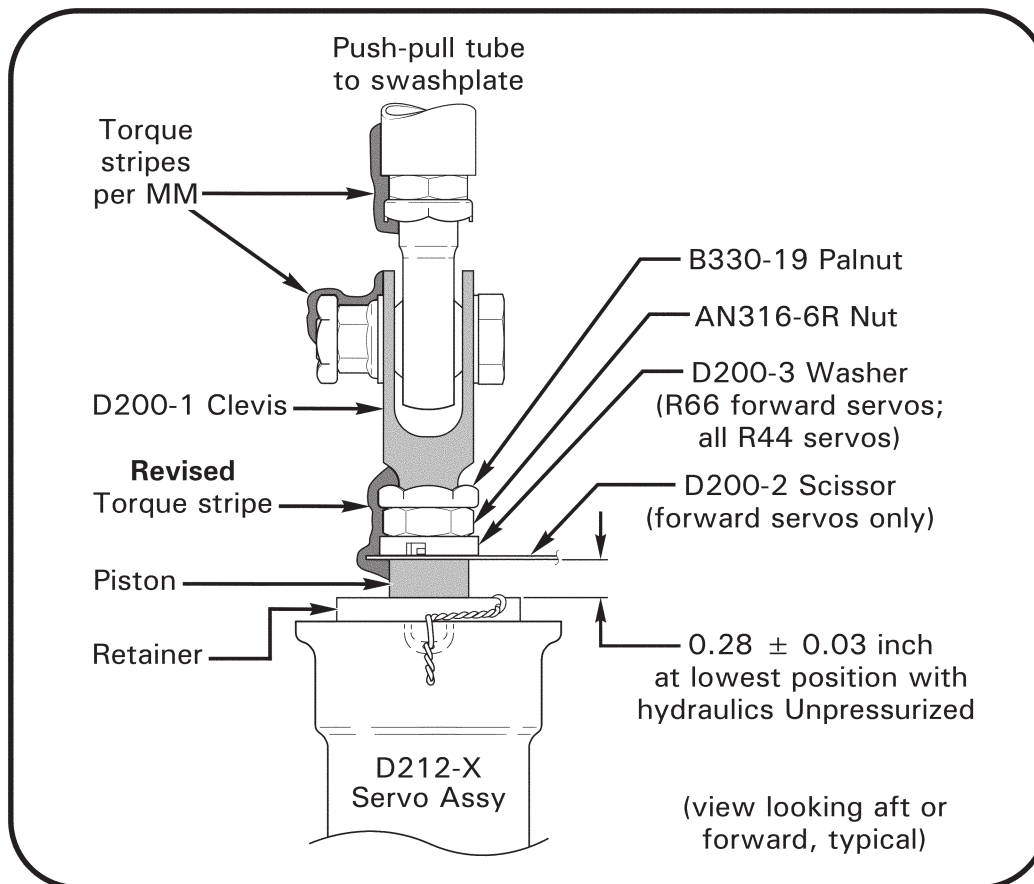
### HYDRAULIC SERVO CLEVIS

The flight control connections between MR blades and hydraulic servos are highly loaded and deserve close attention during scheduled inspections. See following page for revised, servo clevis torque-stripe procedure.

When applying torque stripe to the D200-1 clevis-to-hydraulic servo connection, the stripe must extend from the clevis, across all hardware, to the piston. Ensure torque stripe does not contact retainer when piston is in lowest position.
