**R44 SERVICE BULLETIN SB-120**

**SUBJECT:** Clutch Assembly Magnetic Plug Retrofit and Inspection

**EFFECTIVITY:** C018-2, -3, -4, and -5 clutch assemblies without factory-installed B569-1 magnetic plugs are affected by this bulletin. Factory-installed B569-1 magnetic plugs began production in October 2026 and have a dot of orange paint applied to head; see Reference Image on page 5.

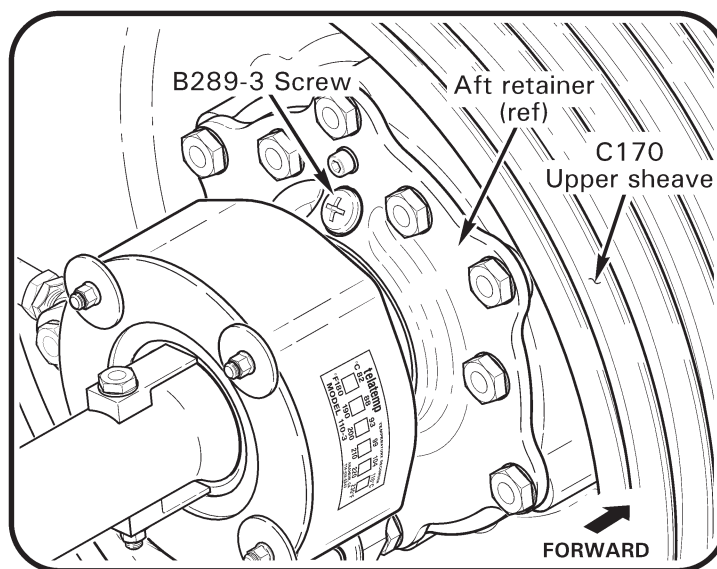
**Figure 1: B289-3 Screw Location in C168-5 Retainer**

3. Refer to Figure 1. Rotate upper sheave by hand to locate B289-3 screw in both forward and aft retainers. If either screw is not present, then clutch assembly must be removed from service.

4. Rotate upper sheave until forward retainer's B289-3 screw is at highest position. Remove screw. Install B569-1 magnetic plug (#3 Phillips) and torque to 50 inch-pounds.

5. Rotate upper sheave until aft retainer's B289-3 screw is at highest position. Remove screw. If fluid level is not visible, top off fluid with A257-4 lubricant. Install B569-1 magnetic plug and torque to 50 inch-pounds.

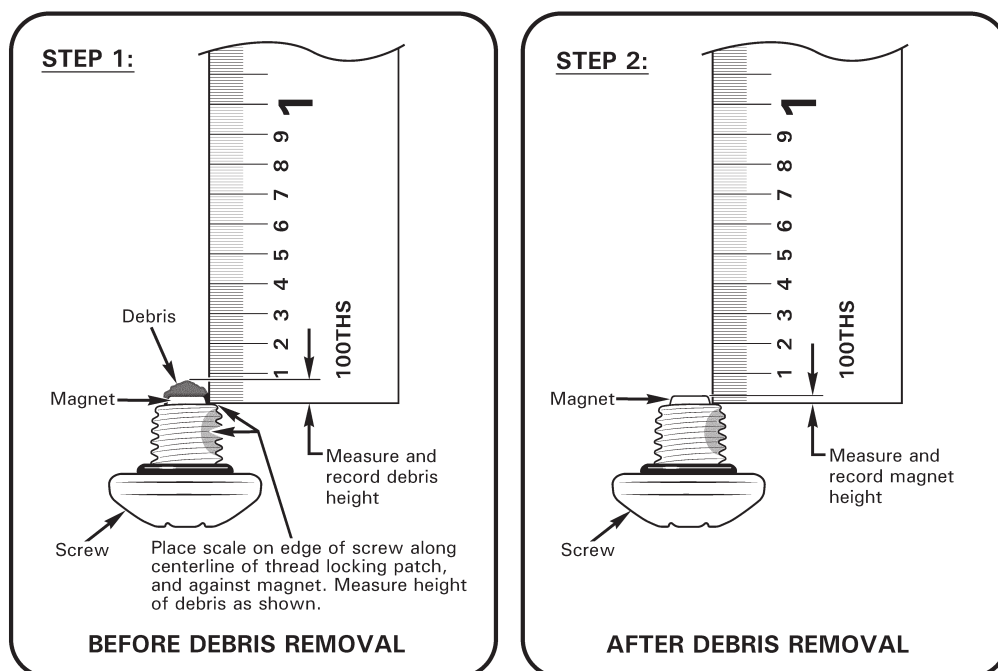
**Figure 2: B569-1 Magnetic Plug Debris Measurement**

5. Measure and record combined debris and magnet height using a 0.01 inch resolution scale per Figure 2 Step 1.
6. Use a clean, lint-free cloth to collect all debris from magnetic plug; set cloth aside for later inspection.
7. Measure and record magnet height using a 0.01 inch resolution scale per Figure 2 Step 2.
8. Calculate debris height by subtracting magnet height from total height of magnet with debris. Debris height = [(step 5 measurement) – (step 7 measurement)]. Record result.

9. If calculated debris height is less than or equal to 0.02 inch, proceed to step 10. If calculated debris height exceeds 0.02 inch, record failed inspection result.

10. Visually inspect debris on cloth(s) collected in step 6. Debris may be black flake(s), chip(s), small particle accumulation, and/or thin metallic slivers. If any piece of debris exceeds 0.050 inch in any direction, record failed inspection result.
