CHAPTER 2
INSPECTION

INSPECTION

2.000 Introduction

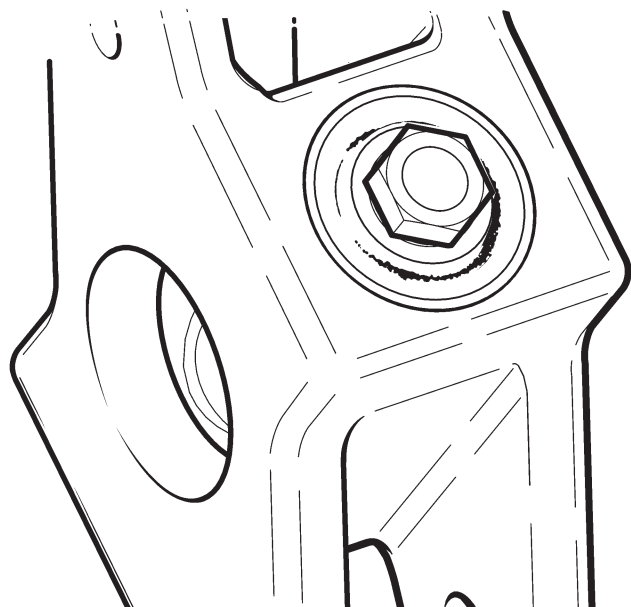
FIGURE 2-2A
ELASTOMER FATIGUE

Small surface cracks (fatigue cracks) and elastomer dust or “eraser crumbs” (see Figure 2-2A) are normal and are not cause for replacement. As cracks grow, enough elastomer will be lost to cause reduced stiffness and increased vibration. If deep (greater than 0.10 inch) cracks are present over more than 25% of elastomer face, replace bearing.

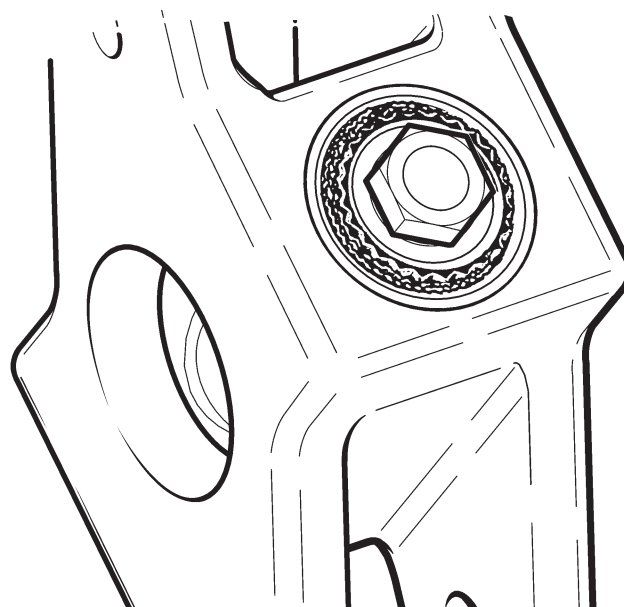
FIGURE 2-2B
ELASTOMER OIL CONTAMINATION

Avoid exposure to oil, grease, hydraulic fluid, cleaning solvent, and rust-preventative fluids. Immediately wash off any such contaminants with detergent and water. Contaminated bearings exhibit swelling, wavy edges, or debonding (see Figure 2-2B) and must be replaced.

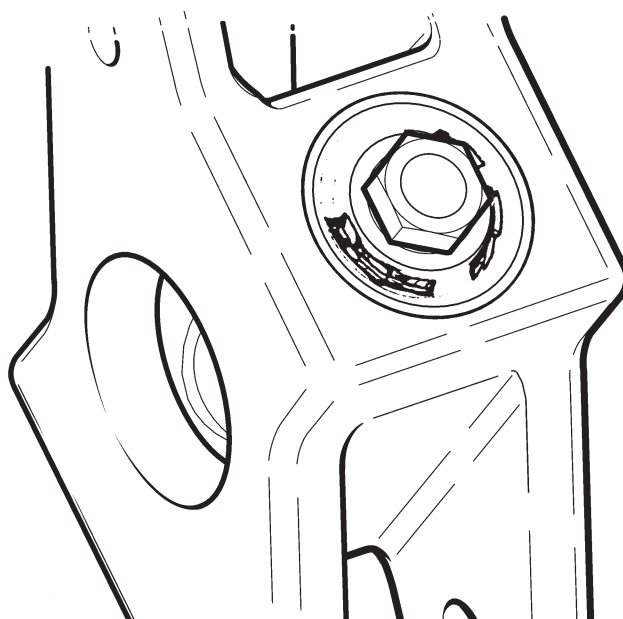
FIGURE 2-2C
ELASTOMER OVERLOAD

Overload occurs when elastomer’s tensile strength or rubber-to-metal bond strength is exceeded. This can occur when normal loads are applied to a bearing weakened by fatigue or oil contamination. Overload is indicated by large extrusions from and large clean cracks in elastomer as shown in Figure 2-2C.

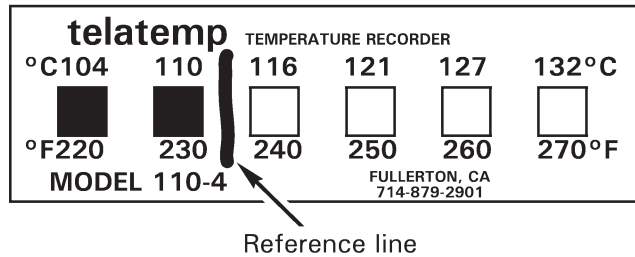
FIGURE 2-3 TELATEMP INDICATOR WITH DRAWN REFERENCE LINE

Refer to Figure 2-3. Self-adhesive Telatemp indicators record changes in operating temperatures of bearings and gearboxes. To use a Telatemp, draw a reference line between the highest temperature square which has darkened during normal operation and the next undarkened square. During every check thereafter, determine if an additional square has blackened. If an indicated temperature increase cannot be accounted for by a change in operating conditions, carefully examine the component before further flight.

Telatemp can indicate erroneously if contaminated by a petroleum product, typically appearing as white, unactivated square(s) between darkened squares at each end; replace any Telatemp indicating as such and clean area with acetone prior to installing.

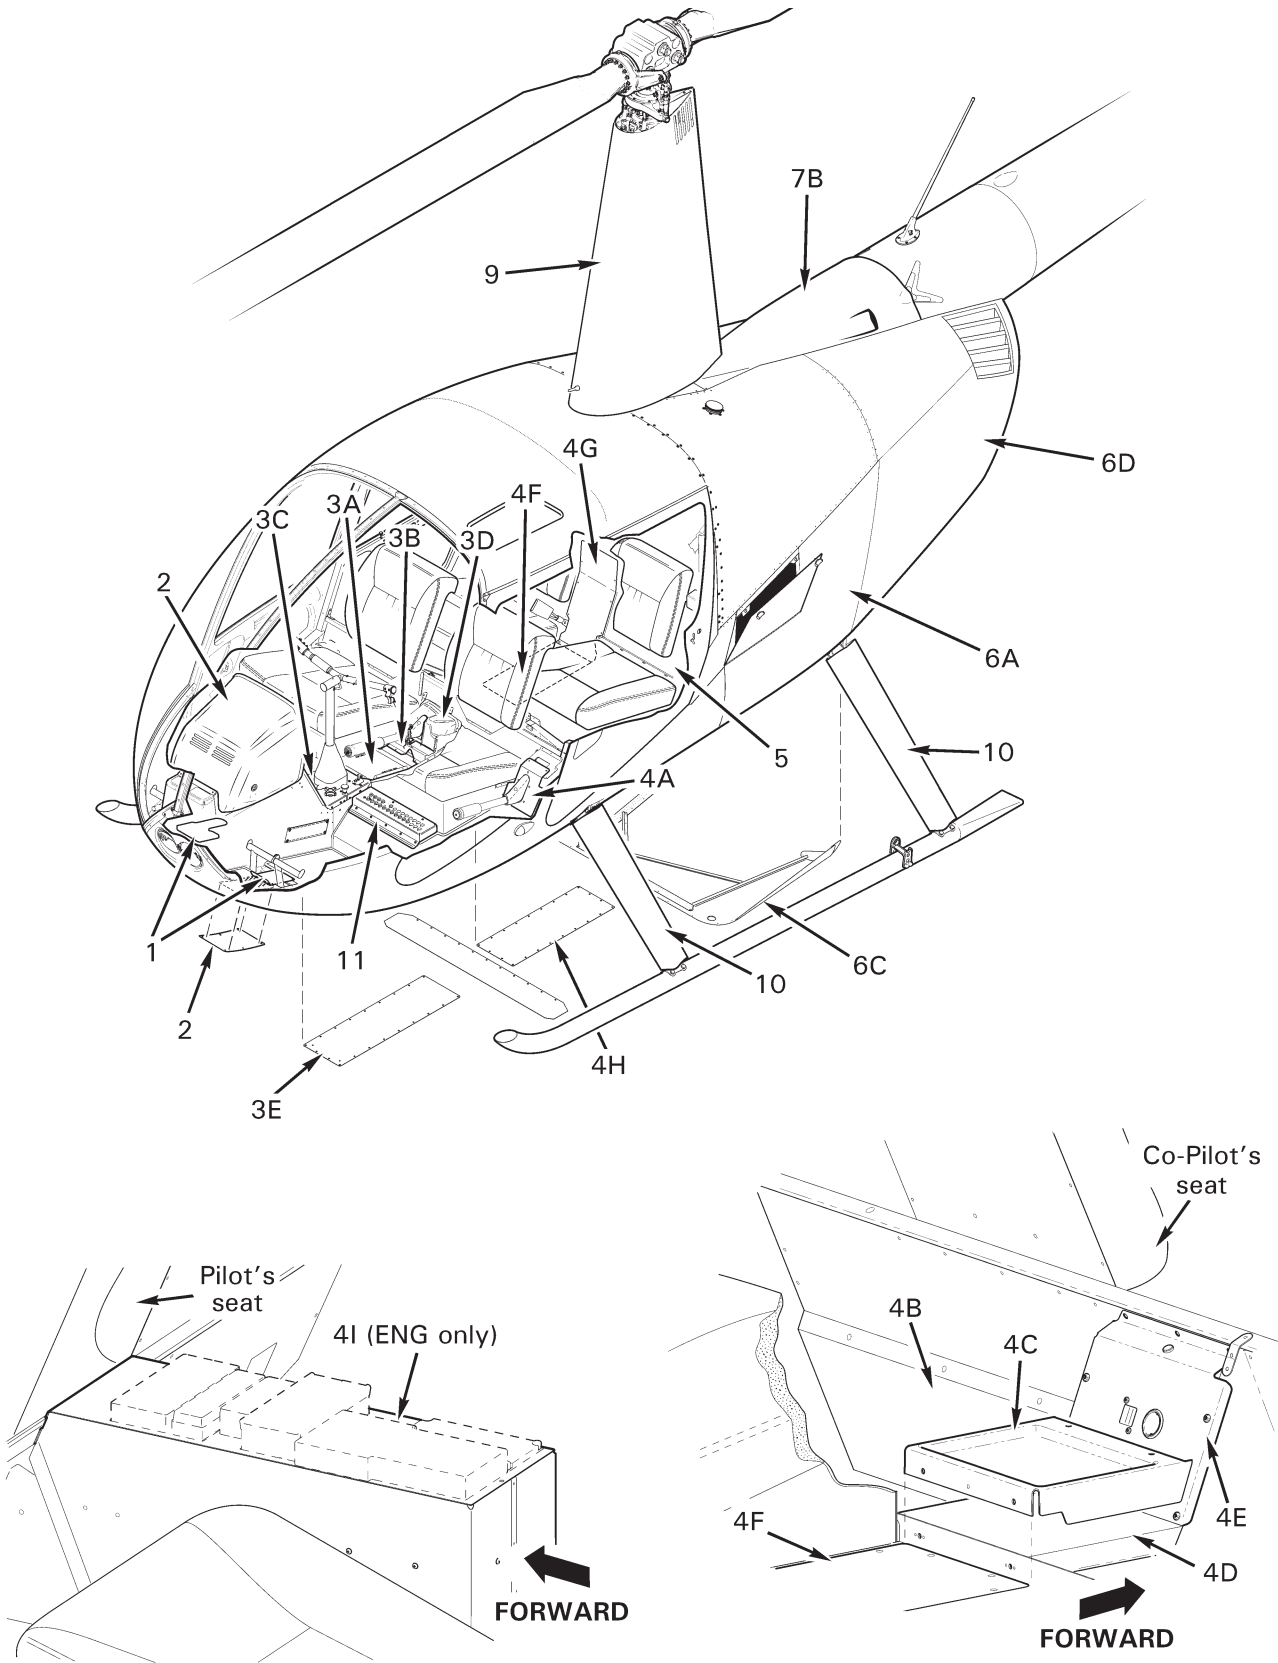
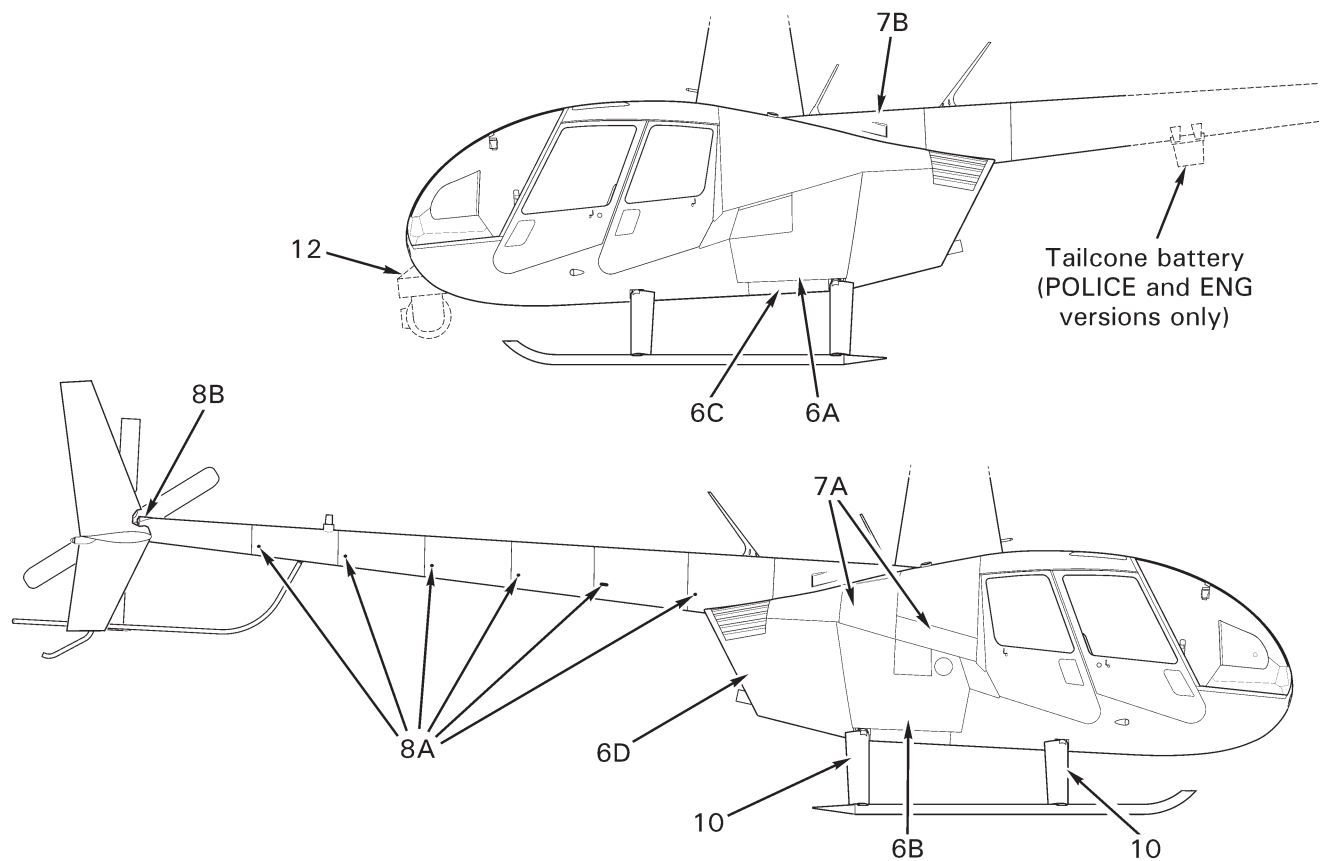
FIGURE 2-4 ACCESS AND INSPECTION PANELS

Numbers in parentheses indicate access location per Figures 2-4 and 2-4A.

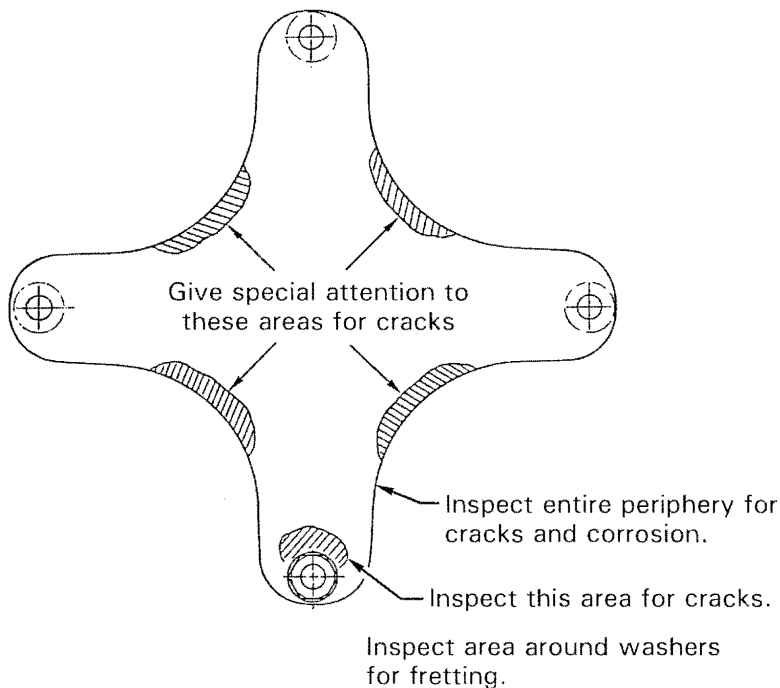
FIGURE 2-5 FLEX PLATE INSPECTION

Forward Flex Plate: Inspect condition, particularly edges. Verify security. Verify bonded washers are securely bonded to both sides of each flex plate arm. Verify operating clearance.

Intermediate Flex Plate and Forward End of Tail Rotor Drive Shaft (see Figure 2-5): Inspect flex plate for cracks and fretting. Inspect yoke-to-drive shaft weld for cracks (steel shafts). _____

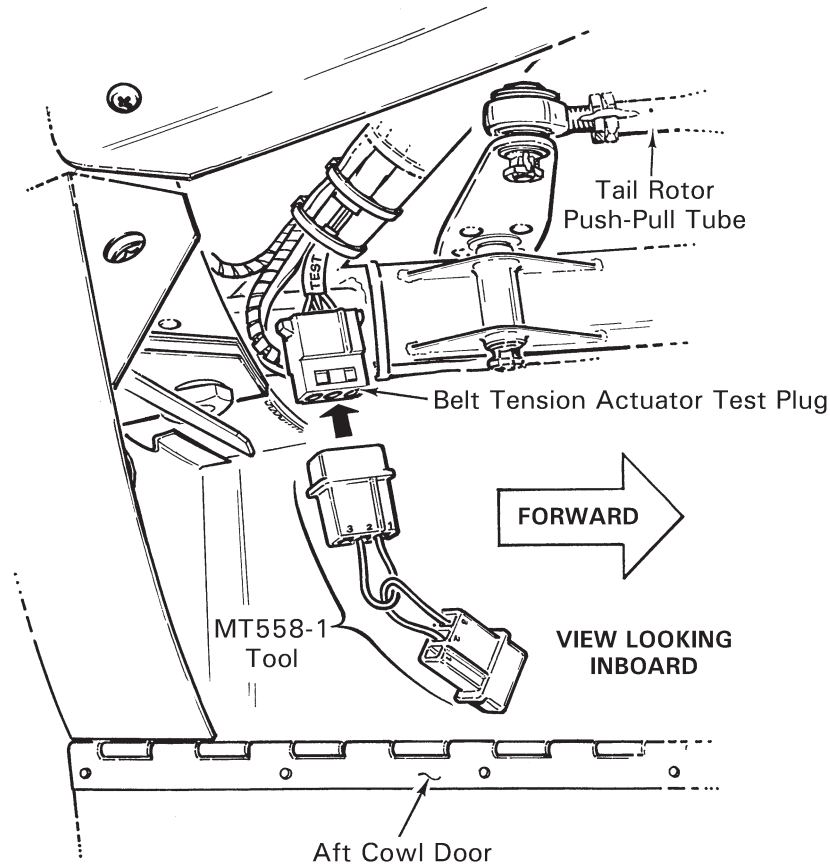
FIGURE 2-6 MT558-1 TOOL INSTALLATION

Check actuator for failed-closed spring switch as follows (actuator electrical harness must be equipped with "Test" plug per Figure 2-6):

If gearmotor activates when installing MT558-1 tool then a spring switch has failed in closed position; immediately remove MT558-1 to prevent actuator damage.

- b. Disconnect MT558-1 tool, connect opposite end to actuator test plug, and verify gearmotor remains off. _____
- c. Disengage clutch and turn BATTERY switch off. _____
- d. MT558-1 pins 1 & 2 jumper tests wire 98 spring switch; pins 2 & 3 jumper tests wire 91 spring switch (see Figure 14-1D). Replace any malfunctioning switch per § 7.550 before further flight. _____

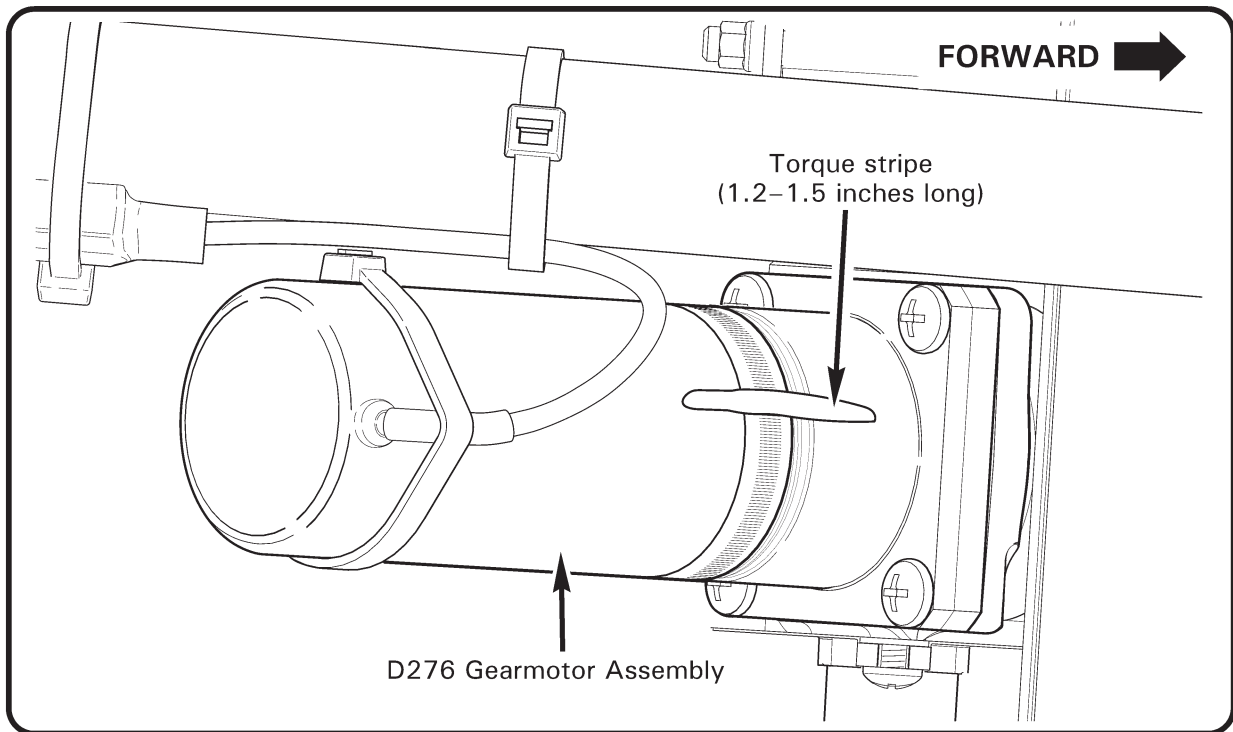
FIGURE 2-6A GEARMOTOR ASSEMBLY TORQUE STRIPE

Gearmotor Assembly Torque Stripe: Refer to Figure 2-6A. Verify torque stripe is not broken or missing. Renew deteriorated torque stripe as required. _____

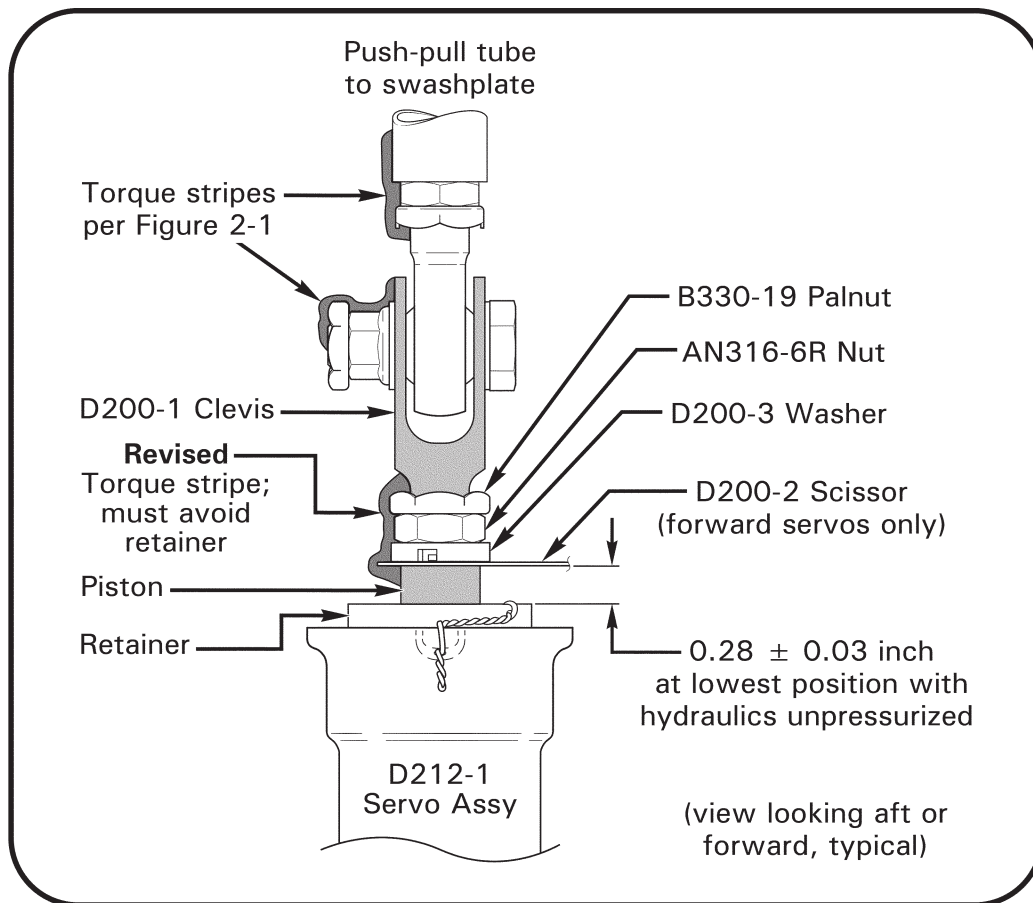
FIGURE 2-7 CLEVIS TORQUE STRIPE

Forward Hydraulic Servos: Inspect condition; verify no obvious defects. Hydraulic fluid seepage is permissible ("seepage" is evidence of fluids without flow, drips, or runs) provided fluid does not contaminate MRGB rubber mounts. Verify servo input rod end/clevis area is clean; cleanse area with non-residue, non-alcoholic solvent as required. Verify approximately 0.040 inch total free-play at servo valve input. Inspect rod ends per § 2.120. Verify valve clearance to surrounding structure while flight controls are moved through full range of travel. Inspect condition and verify security of scissors at upper clevis of servos. Inspect clevis security and torque stripe per Figure 2-7.

Aft Hydraulic Servo: Inspect condition; verify no obvious defects. Hydraulic fluid seepage is permissible ("seepage" is evidence of fluids without flow, drips, or runs) provided fluid does not contaminate MRGB rubber mounts. Verify servo input rod end/clevis area is clean; cleanse area with non-residue, non-alcoholic solvent as required. Verify approximately 0.040 inch total free-play at servo valve input. Inspect rod ends per § 2.120. Verify valve clearance to surrounding structure while flight controls are moved through full range of travel. Inspect clevis security and torque stripe per Figure 2-7.

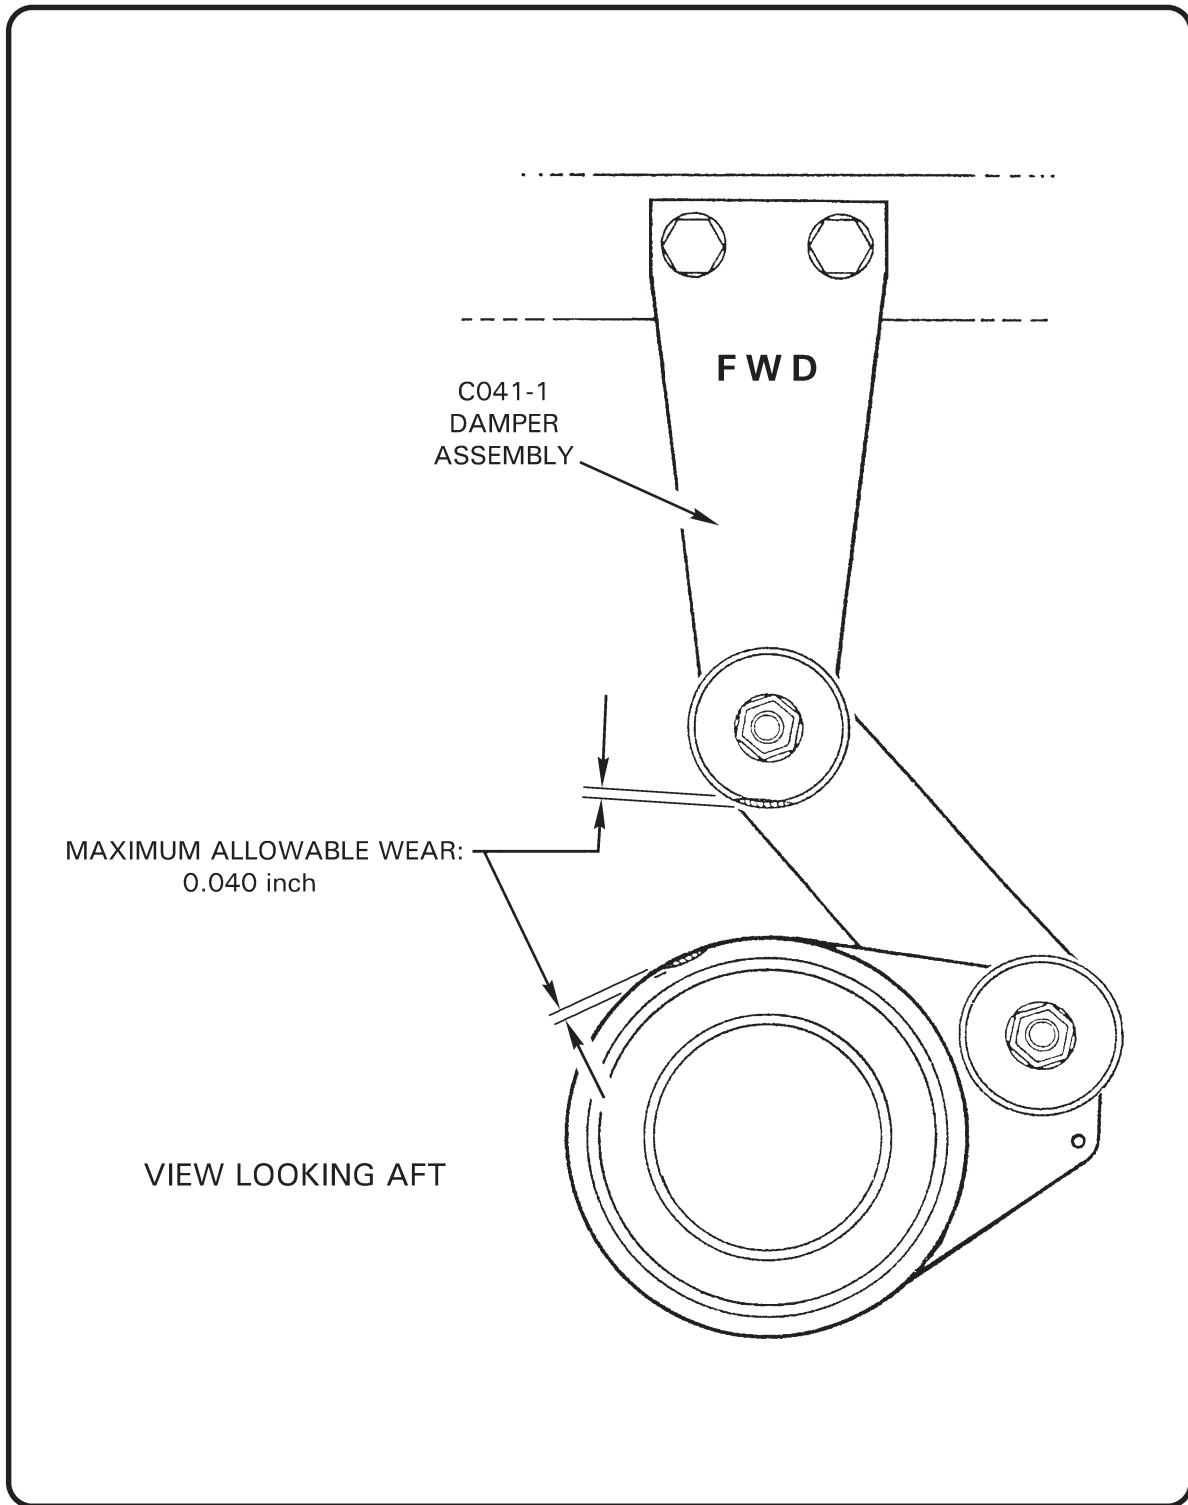
FIGURE 2-8 TAIL ROTOR DRIVE SHAFT DAMPER BEARING INSPECTION

Tail Rotor Drive Shaft Damper Assembly: Verify no obvious damage. Verify integrity of bearing seals. Inspect bearing housing for excessive wear (see Figure 2-8). Verify bearing's inner race-to-drive shaft torque stripe is intact and no evidence of bearing slippage. Verify proper orientation, security, and smooth operation.

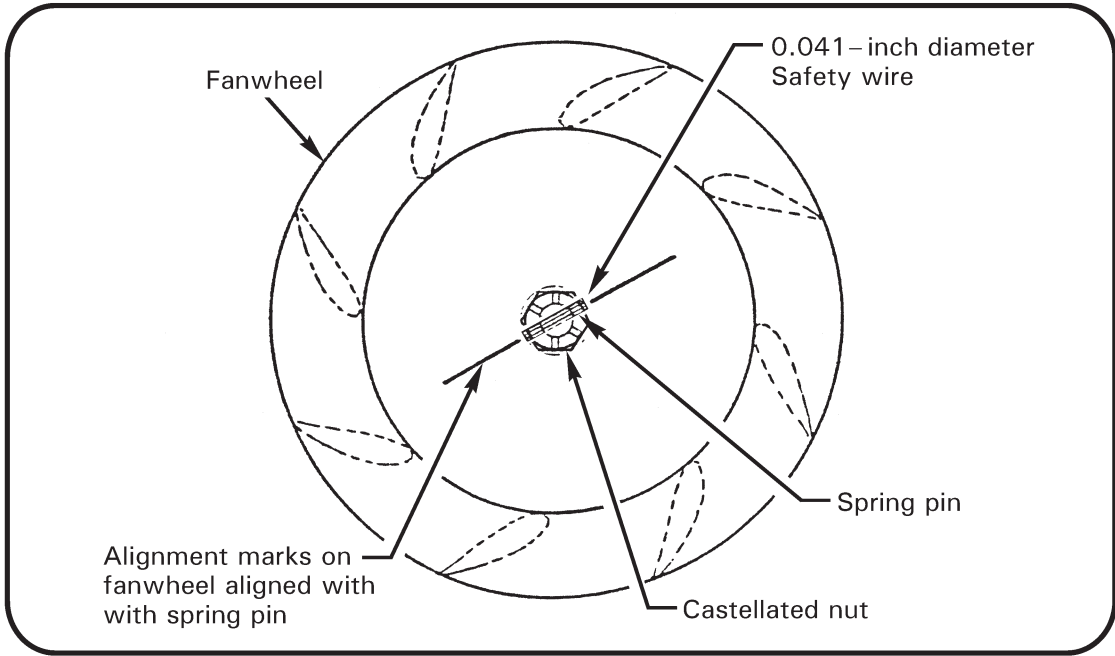
FIGURE 2-10 FANWHEEL ALIGNMENT MARKS

Fanwheel Assembly: Clean and inspect fanwheel assembly for cracks and corrosion. Check leading edge of vanes for damage. Verify spring pin and fanwheel alignment marks are aligned (see Figure 2-10); remove fanwheel and inspect mating surfaces for damage if misalignment is evident.

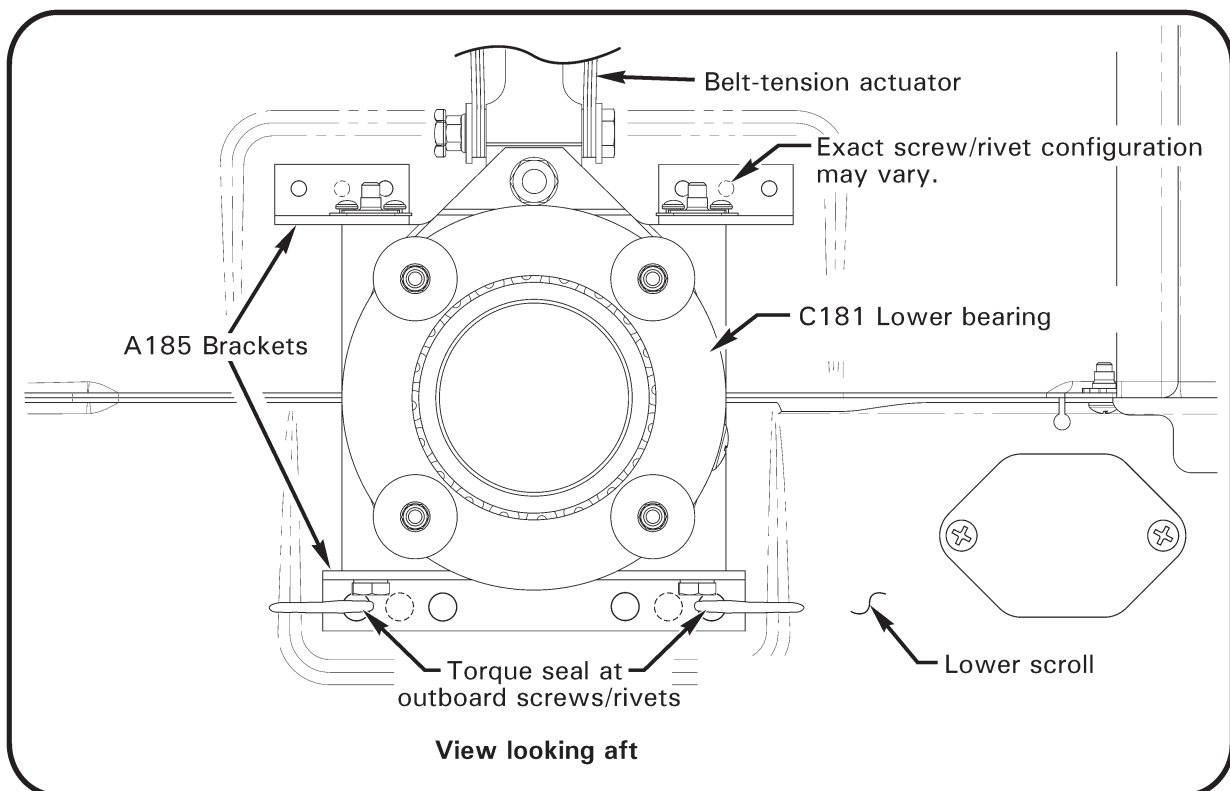
FIGURE 2-11 ACTUATOR LOWER BEARING A185 BRACKETS

Lower Bearing Brackets: Refer to Figure 2-11. Visually inspect A185 brackets and attaching screws/rivets for evidence of fretting or looseness. If evidence of looseness is found, contact RHC Technical Support for repair instructions. On lower A185 bracket, apply torque seal in a horizontal stripe across both outboard screws/rivets to lower scroll to facilitate future inspections.

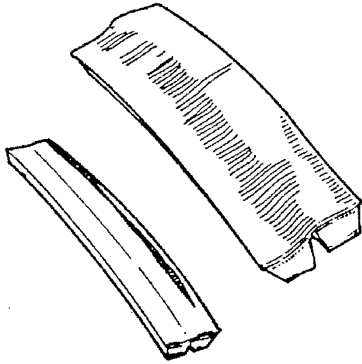
2. Top of tie band frayed or damaged.

CAUSE	REMEDY
Surrounding structure interfering with normal operation of belt.	Reposition affected sheave for proper clearance and align sheaves per Section 7.230.
Foreign material contacting belt.	Remove foreign material

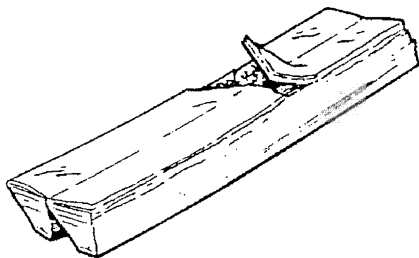
3. Top of tie band blistered or perforated.

CAUSE	REMEDY
Foreign material accumulating between belts.	Check for and remove foreign material.

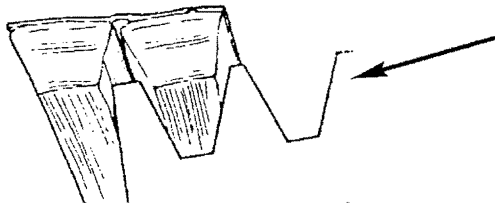
5. BELT RIDING OUTSIDE SHEAVE GROOVE

V-belt has jumped one groove forcing belt out of sheave.

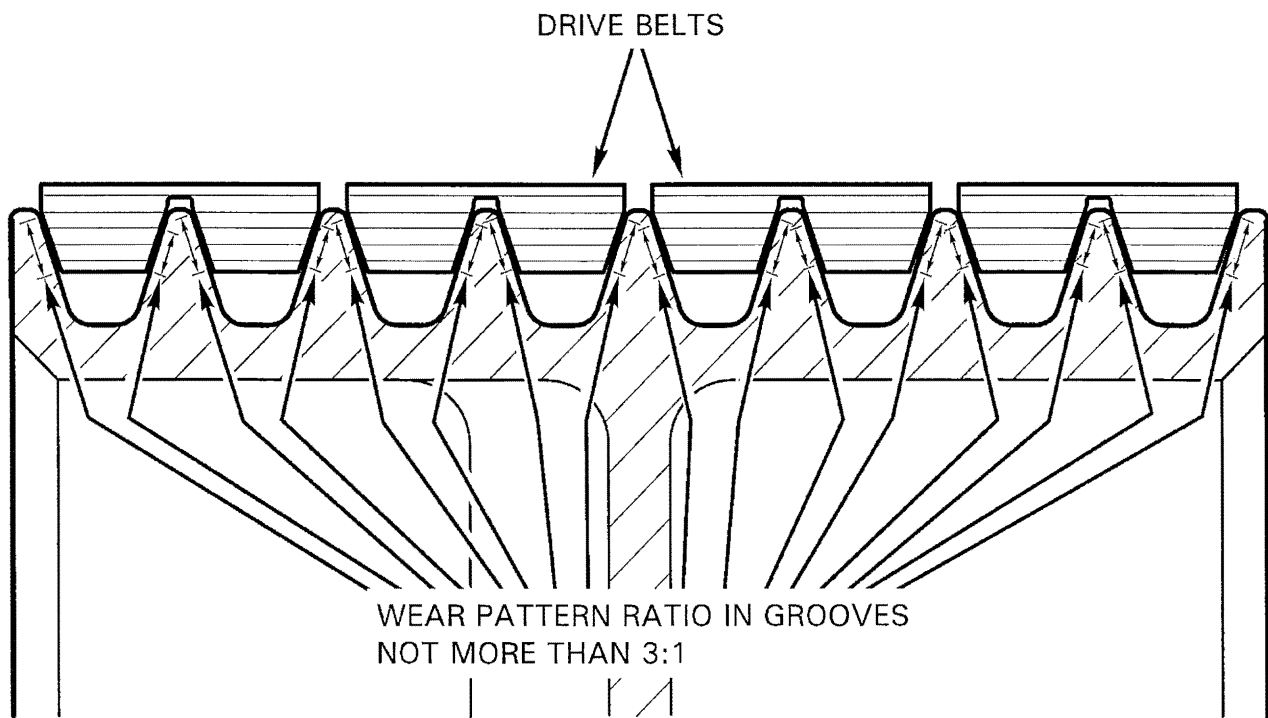
FIGURE 2-13 LOWER SHEAVE V-BELT WEAR PATTERN

Observe wear patterns in paint primer in all eight grooves of lower V-belt sheave. Wear patterns on both sides of all eight grooves should appear very similar. Wear patterns which vary in width less than a 3-to-1 ratio groove to groove are acceptable.

If wear pattern is noticeably different from groove to groove, inspect sheave grooves for roughness or excessive wear and replace V-belts per Section 7.280. If wear patterns are all similar and alignment and condition of belts and sheaves are satisfactory, no further action is required.

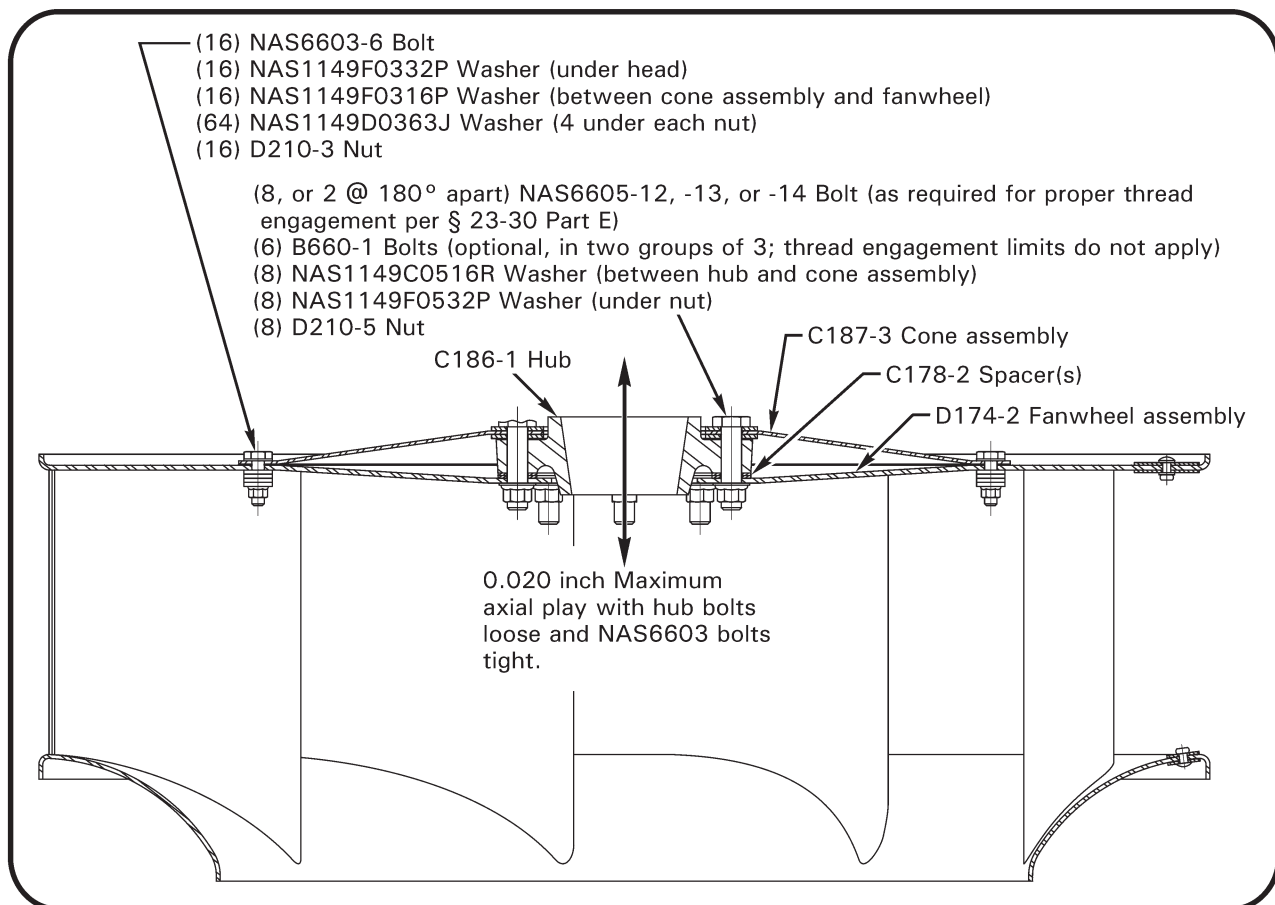
FIGURE 2-19 D174-2 FANWHEEL ASSEMBLY

1. If installed, remove D174-2 fanwheel assembly per § 6.210.
2. Mark fanwheel assembly parts, including balancing hardware, for identical reassembly.
3. Refer to Figure 2-19. Loosen bolts securing C187-3 cone assembly and C186-1 hub to fanwheel. Verify hub axial play does not exceed 0.020 inch with hub bolts loose and NAS6603 bolts tight.
4. Remove hardware securing cone assembly, hub, and C178-2 spacer(s) to fanwheel and remove parts, noting relative locations for identical reassembly.
5. Visually inspect all components for obvious damage. Verify no elongation of fastener holes. Replace parts as required.
6. Assemble fanwheel wet with approved primer (chromate primer preferred; refer to § 23-75) between all clamping surfaces; while primer is wet, special torque D210 nuts per § 23-33. Apply B270-21 protectant to threads and tip of B660-1 bolts, if installed.

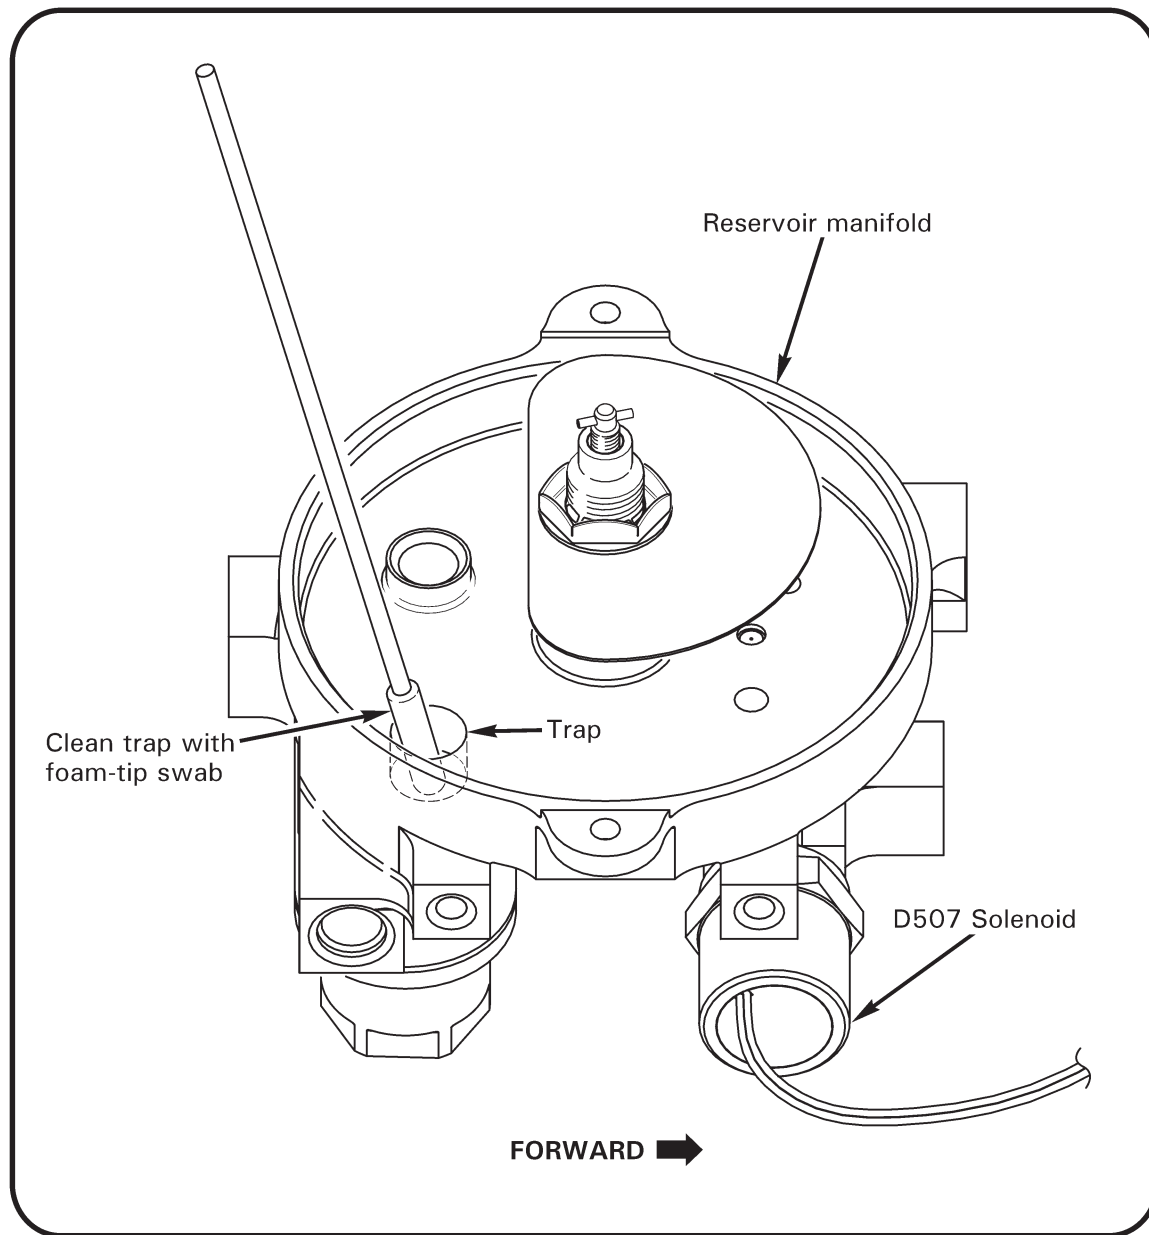
FIGURE 2-20 HYDRAULIC RESERVOIR INSPECTION

4. Lift off D486-1 housing from manifold (there will be some resistance due to o-ring packing).
5. Refer to Figure 2-20. Avoid disturbing orientation of sheet-metal baffle. Suction remaining fluid from manifold using suitable, clean, plastic tube (do not use metal tool). Using lint-free wipe, clean exposed interior of manifold. Wipe out any residue from trap (blind hole) with clean, foam-tip swab.
