CHAPTER 2

INSPECTION

2.000 Introduction

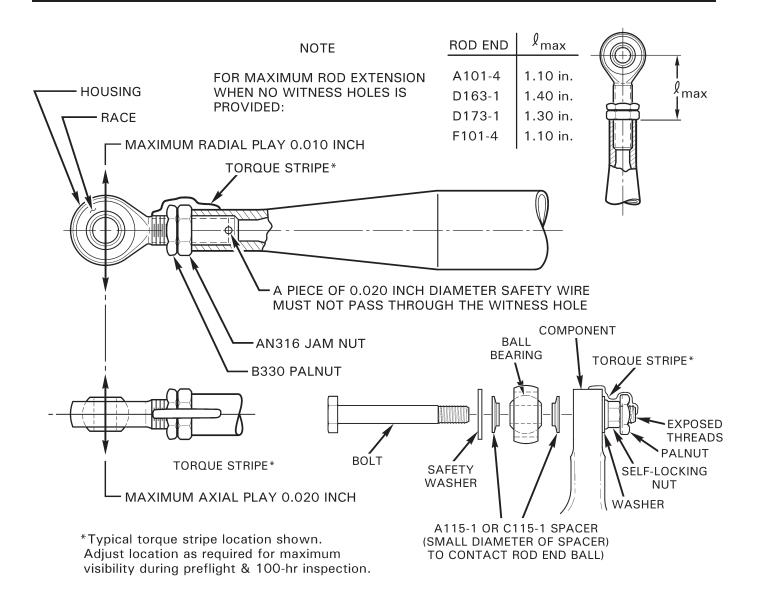
FIGURE 2-1 ROD END AND SPHERICAL BEARING PLAY LIMITS AND TORQUE STRIPE APPLICATION

- Maximum axial play: 0.020 inch (for A104-4 bearing only: 0.035 inch axial play)
 Maximum radial play: 0.010 inch
- 2. Looseness between spherical bearing outer race & rod end housing, or between spherical bearing outer race & part, is not permitted.

- 4. Rod end jam nuts and palnuts must be torqued per § 23-32 and torque striped per Figure 2-1 at the most visible position for pre-flight inspection. Torque stripe must extend across nuts to both rod end shank and push-pull tube (or pitch link barrel, yoke, support, strut, etc.). Torque stripes are subject to deterioration and must be periodically renewed.

If, during inspection, the remaining torque stripe on a fastener is insufficient to determine joint integrity, then remove accompanying palnut as required and apply specified torque to fastener. If fastener moves, disassemble joint and inspect parts for damage such as fretting, thread deformation, hole elongation, etc.; replace damaged parts. If fastener does not move, install new palnut as required & standard torque per § 1.320. Torque stripe fastener per Figure 2-1.

Elastic Trim Cords – Cyclic : With cyclic forward-right, feel forward elastic trim cords for voids which may indicate broken strands.						
	Heater Hose: Check heater hose for collapsed areas and chafing.						
	Fasteners and Torque Stripes: Inspect condition and verify security of all fasteners. Renew deteriorated torque stripes per Figure 2-1.

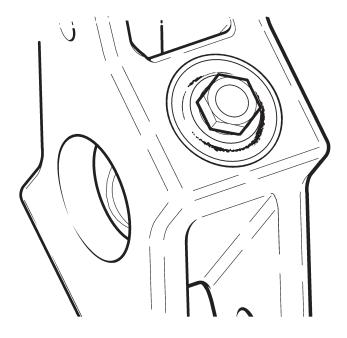
FIGURE 2-2A ELASTOMER FATIGUE

Small surface cracks (fatigue cracks) and elastomer dust or "eraser crumbs" (see Figure 2-2A) are normal and are not cause for replacement. As cracks grow, enough elastomer will be lost to cause reduced stiffness and increased vibration. If deep (greater than 0.10 inch) cracks are present over more than 25% of elastomer face, replace bearing.

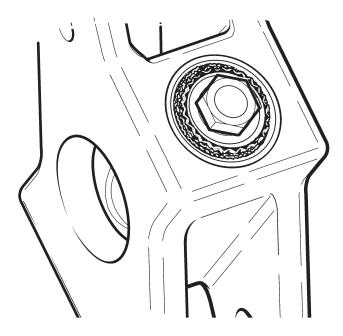
FIGURE 2-2B ELASTOMER OIL CONTAMINATION

Avoid exposure to oil, grease, hydraulic fluid, cleaning solvent, and rust-preventative fluids. Immediately wash off any such contaminants with detergent and water. Contaminated bearings exhibit swelling, wavy edges, or debonding (see Figure 2-2B) and must be replaced.

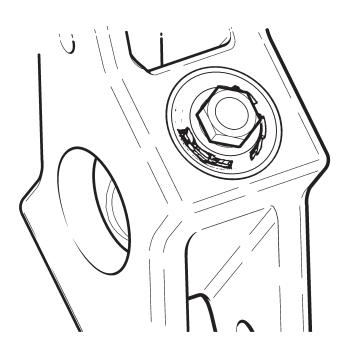
FIGURE 2-2C ELASTOMER OVERLOAD

Overload occurs when elastomer's tensile strength or rubber-to-metal bond strength is exceeded. This can occur when normal loads are applied to a bearing weakened by fatigue or oil contamination. Overload is indicated by large extrusions from and large clean cracks in elastomer as shown in Figure 2-2C.

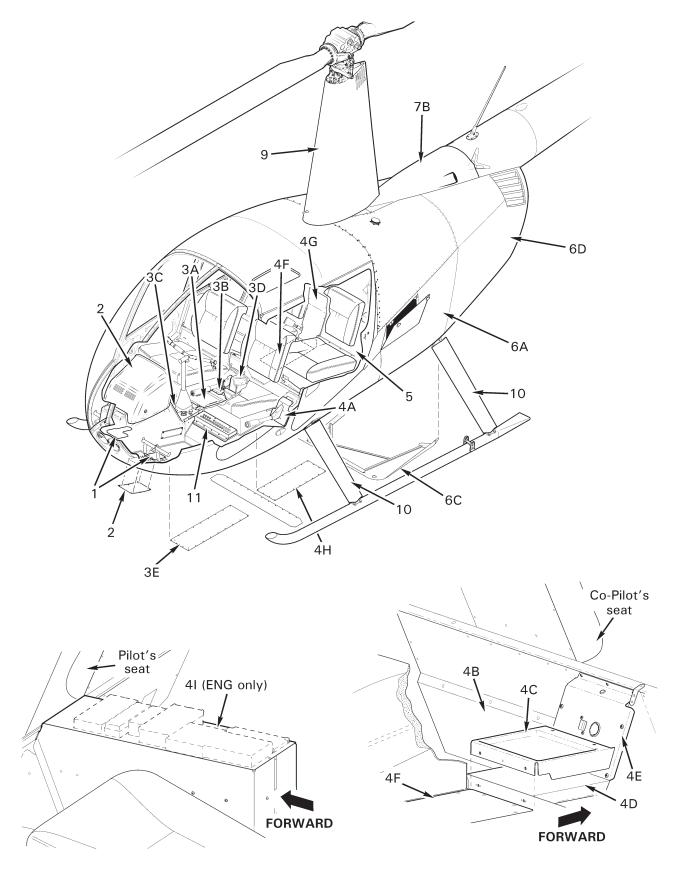
FIGURE 2-4 ACCESS AND INSPECTION PANELS

Numbers in parentheses indicate access location per Figures 2-4 and 2-4A.

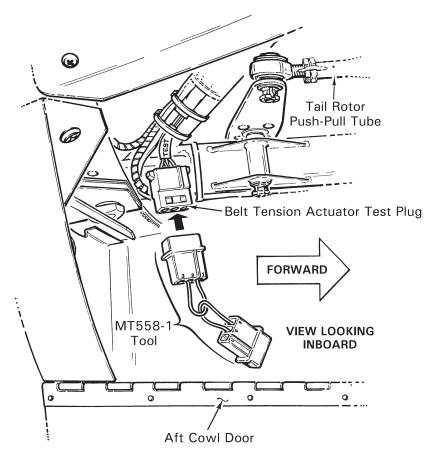
FIGURE 2-6 MT558-1 TOOL INSTALLATION

Check actuator for failed-closed spring switch as follows (actuator electrical harness must be equipped with "Test" plug per Figure 2-6):

If gearmotor activates when installing MT558-1 tool then a spring switch has failed in closed position; immediately remove MT558-1 to prevent actuator damage.

- b. Disconnect MT558-1 tool, connect opposite end to actuator test plug, and verify gearmotor remains off.
- c. Disengage clutch and turn BATTERY switch off.
- d. MT558-1 pins 1 & 2 jumper tests wire 98 spring switch; pins 2 & 3 jumper tests wire 91 spring switch (see Figure 14-1D). Replace any malfunctioning switch per § 7.550 before further flight.

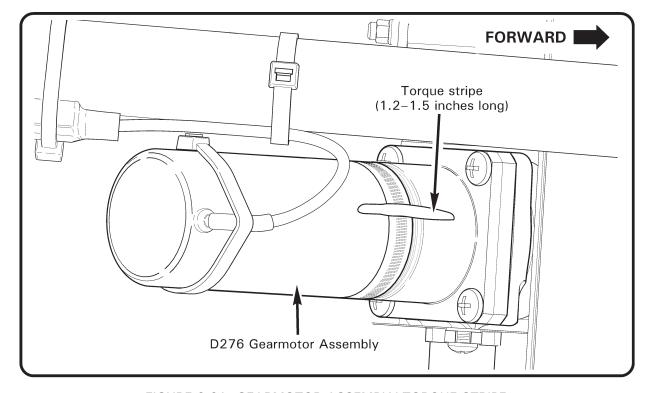
FIGURE 2-6A GEARMOTOR ASSEMBLY TORQUE STRIPE

Gearmotor Assembly Torque Stripe: Refer to Figure 2-6A. Verify torque stripe is not broken or missing. Renew deteriorated torque stripe as required. ___

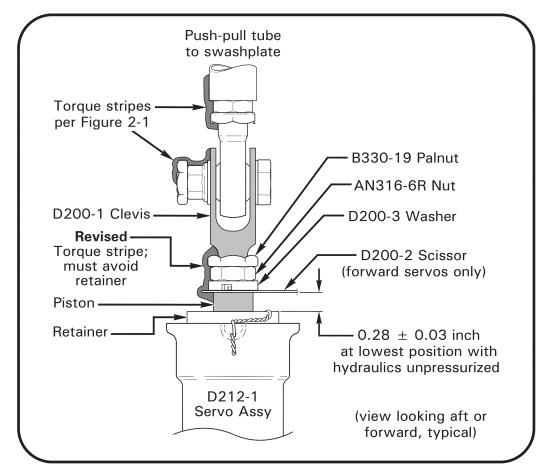
FIGURE 2-7 CLEVIS TORQUE STRIPE

Forward Hydraulic Servos: Inspect condition; verify no obvious defects. Hydraulic fluid seepage is permissible ("seepage" is evidence of fluids without flow, drips, or runs) provided fluid does not contaminate MRGB rubber mounts. Verify servo input rod end/clevis area is clean; cleanse area with non-residue, non-alcoholic solvent as required. Verify approximately 0.040 inch total free-play at servo valve input. Inspect rod ends per § 2.120. Verify valve clearance to surrounding structure while flight controls are moved through full range of travel. Inspect condition and verify security of scissors at upper clevis of servos. Inspect clevis security and torque stripe per Figure 2-7.

Aft Hydraulic Servo: Inspect condition; verify no obvious defects. Hydraulic fluid seepage is permissible ("seepage" is evidence of fluids without flow, drips, or runs) provided fluid does not contaminate MRGB rubber mounts. Verify servo input rod end/clevis area is clean; cleanse area with non-residue, non-alcoholic solvent as required. Verify approximately 0.040 inch total free-play at servo valve input. Inspect rod ends per § 2.120. Verify valve clearance to surrounding structure while flight controls are moved through full range of travel. Inspect clevis security and torque stripe per Figure 2-7.

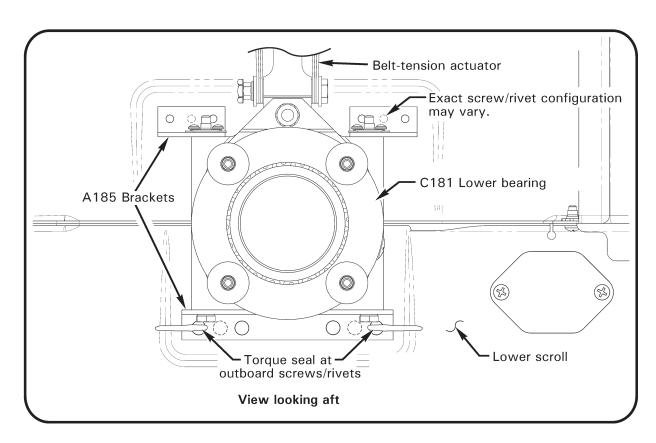
FIGURE 2-11 ACTUATOR LOWER BEARING A185 BRACKETS

Lower Bearing Brackets: Refer to Figure 2-11. Visually inspect A185 brackets and attaching screws/rivets for evidence of fretting or looseness. If evidence of looseness is found, contact RHC Technical Support for repair instructions. On lower A185 bracket, apply torque seal in a horizontal stripe across both outboard screws/rivets to lower scroll to facilitate future inspections.

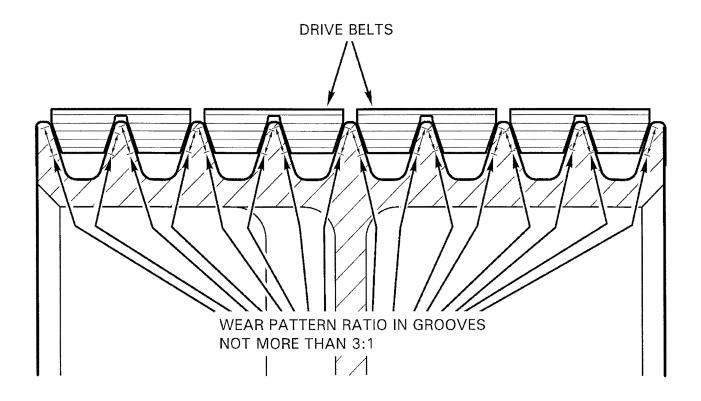
FIGURE 2-13 LOWER SHEAVE V-BELT WEAR PATTERN

Observe wear patterns in paint primer in all eight grooves of lower V-belt sheave. Wear patterns on both sides of all eight grooves should appear very similar. Wear patterns which vary in width less than a 3-to-1 ratio groove to groove are acceptable.

If wear pattern is noticeably different from groove to groove, inspect sheave grooves for roughness or excessive wear and replace V-belts per Section 7.280. If wear patterns are all similar and alignment and condition of belts and sheaves are satisfactory, no further action is required.

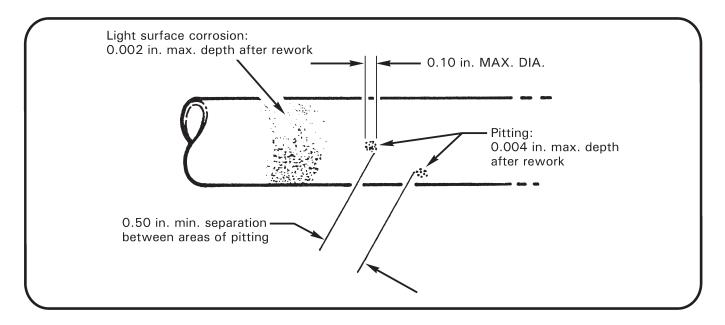
FIGURE 2-16 UPPER FRAME CORROSION REMOVAL LIMITATIONS

2.561 Corrosion on CO20 Upper Steel Tube Frame

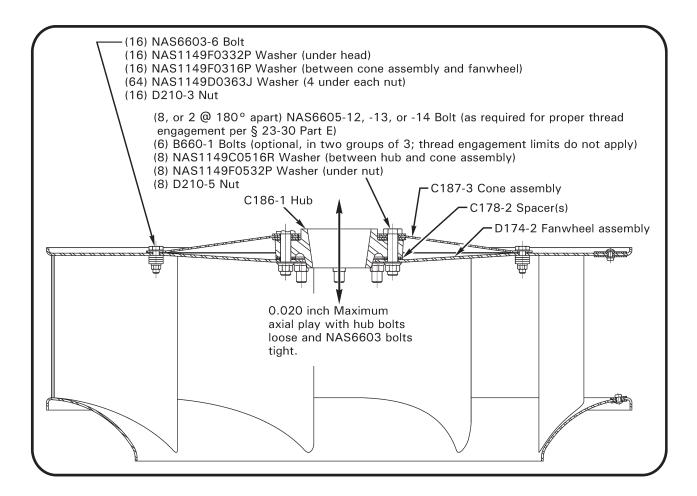
FIGURE 2-19 D174-2 FANWHEEL ASSEMBLY

- 1. If installed, remove D174-2 fanwheel assembly per § 6.210.
- 2. Mark fanwheel assembly parts, including balancing hardware, for identical reassembly.
- 3. Refer to Figure 2-19. Loosen bolts securing C187-3 cone assembly and C186-1 hub to fanwheel. Verify hub axial play does not exceed 0.020 inch with hub bolts loose and NAS6603 bolts tight.
- 4. Remove hardware securing cone assembly, hub, and C178-2 spacer(s) to fanwheel and remove parts, noting relative locations for identical reassembly.
- 5. Visually inspect all components for obvious damage. Verify no elongation of fastener holes. Replace parts as required.
- 6. Assemble fanwheel wet with approved primer (chromate primer preferred; refer to § 23-75) between all clamping surfaces; while primer is wet, special torque D210 nuts per § 23-33. Apply B270-21 protectant to threads and tip of B660-1 bolts, if installed.
